Project Advice Notice

Whitehorse Centre Building Condition Report

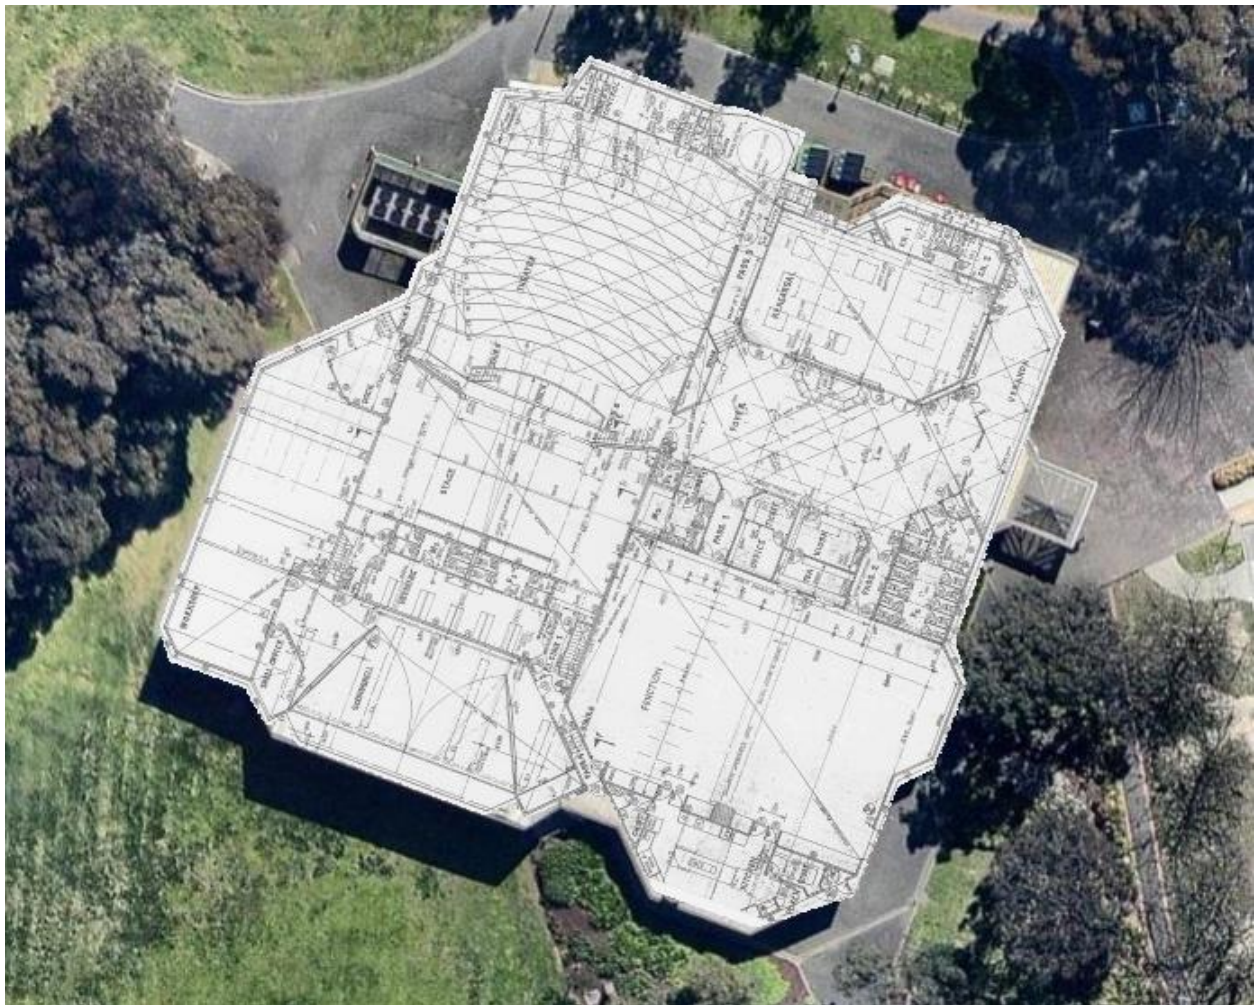
*FIGURE 1 – Whitehorse Centre, 379-397 Whitehorse Rd, Nunawading VIC 3131
(Building floor plan overlay NearMap image)*

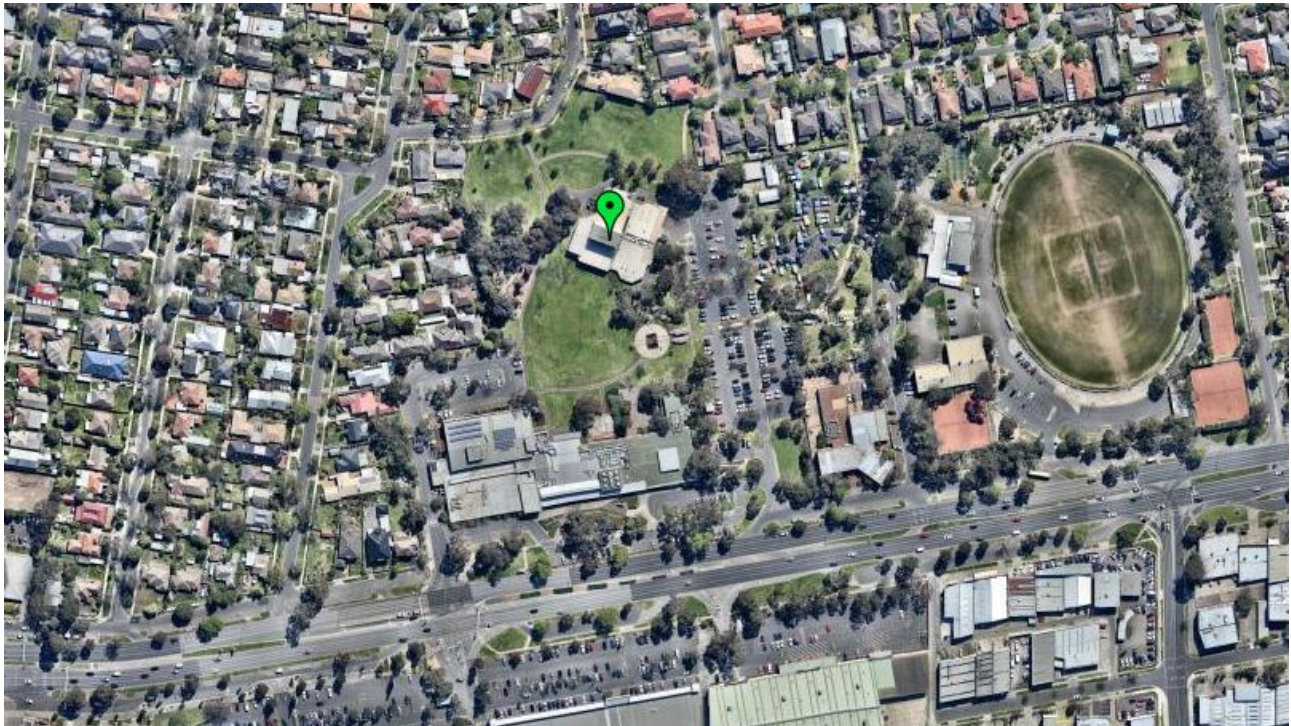
FIGURE 2 – Nearmap aerial shot (North = up)

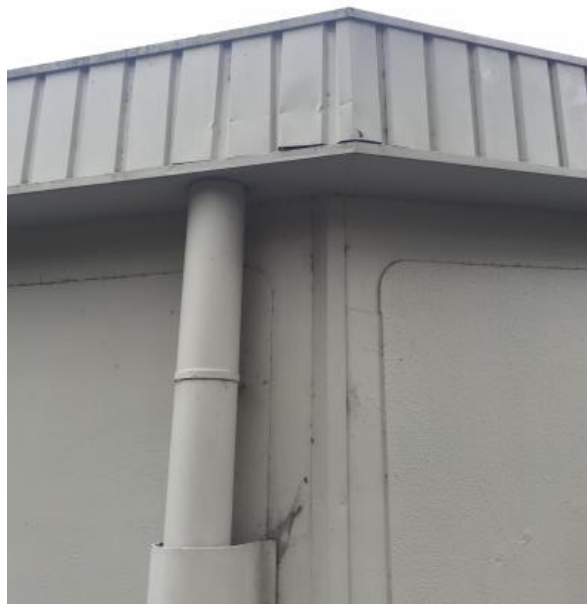
Site Photograph 1 – slight damage to gutter and external clad

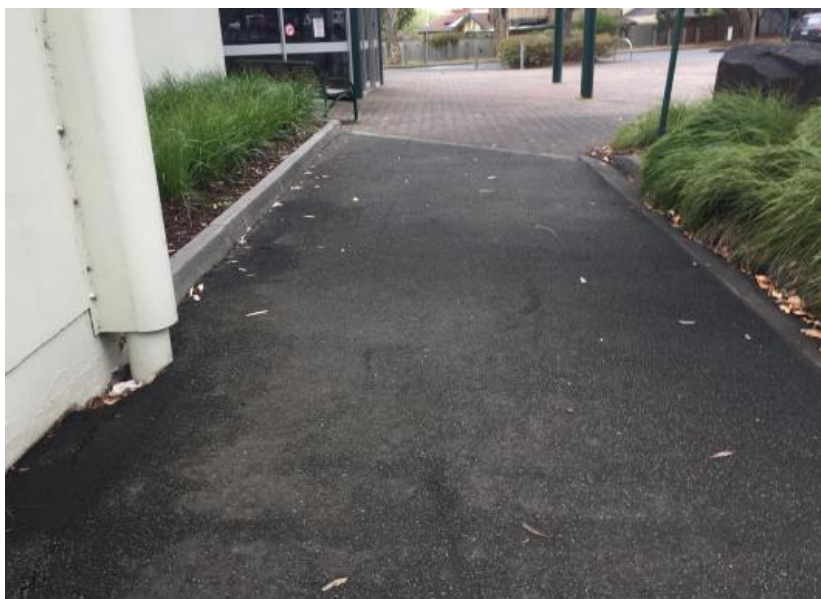
Site Photograph 2 – perimeter pavements generally fall away from building

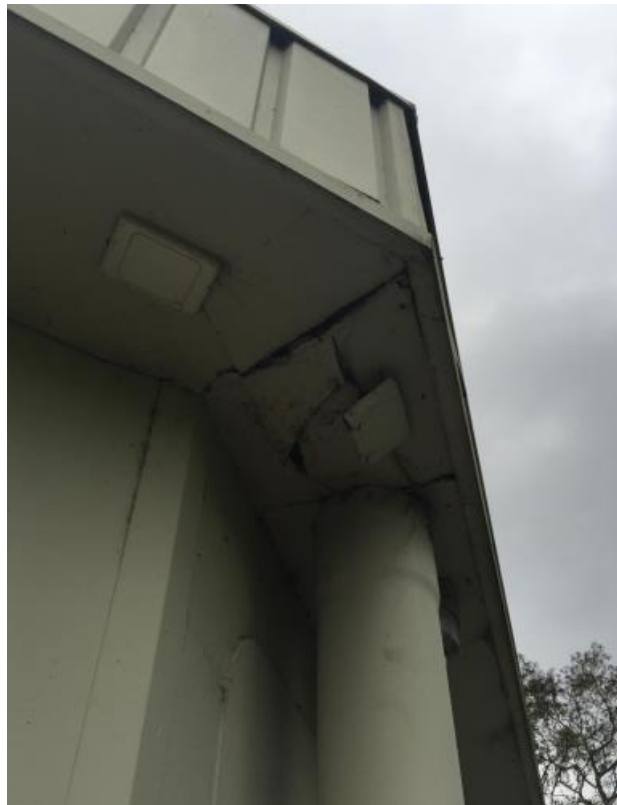
Site Photograph 4 – slight damage to soffit of fascia/eave, appeared to be water damage

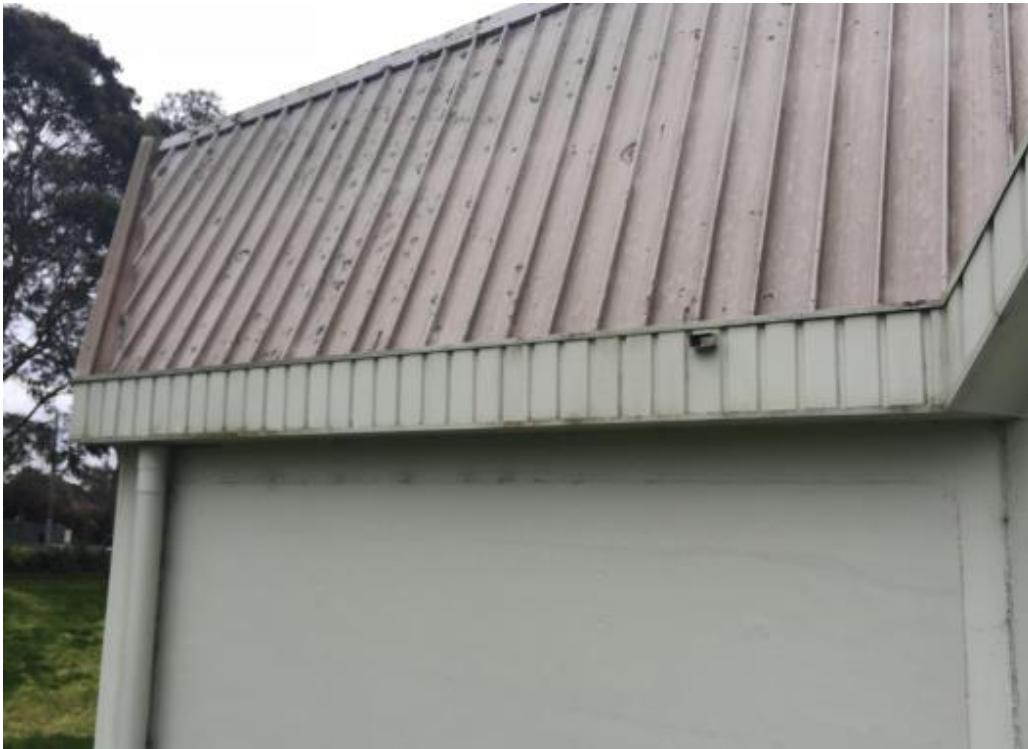
Site Photograph 5 – deterioration sighted in roof sheet

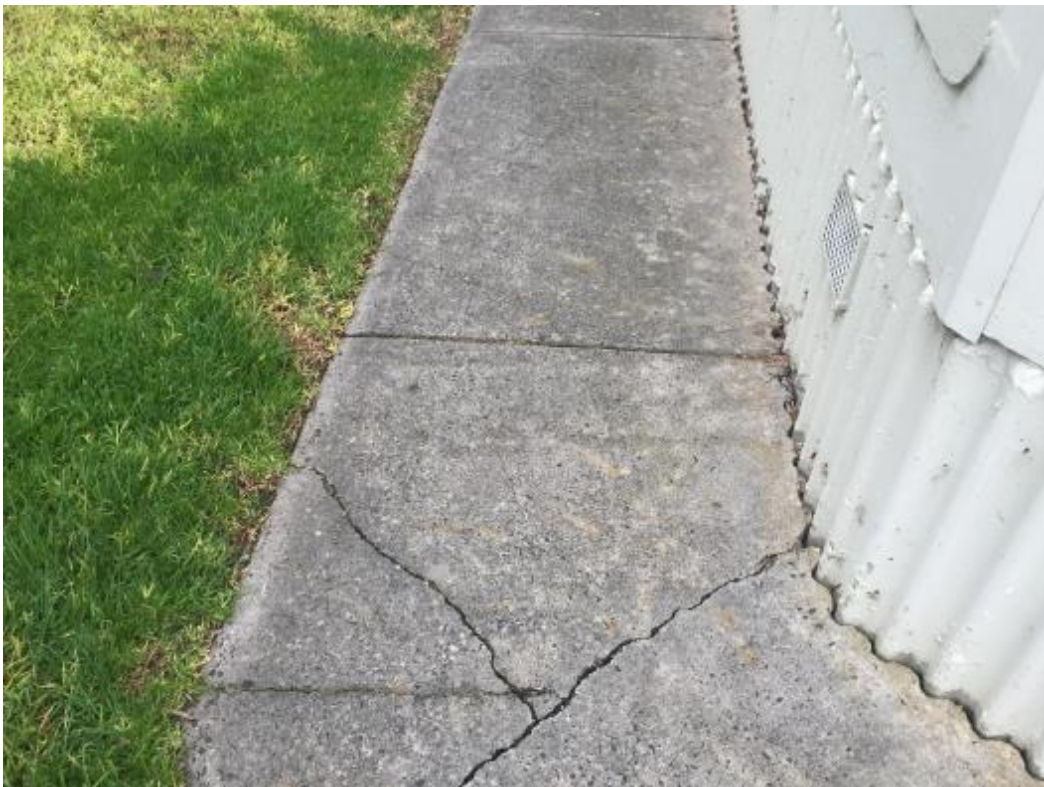
Site Photograph 6 – damage sighted in concrete pavement

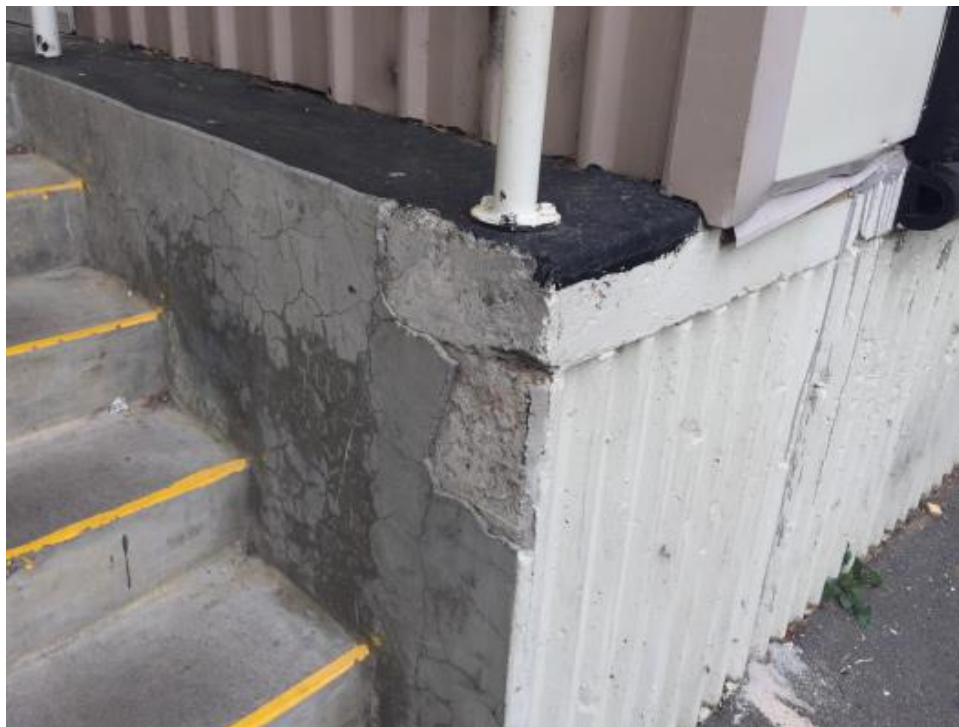
Site Photograph 8 – damage sighted to concrete loading dock, appeared to be hit by vehicle rather than movement

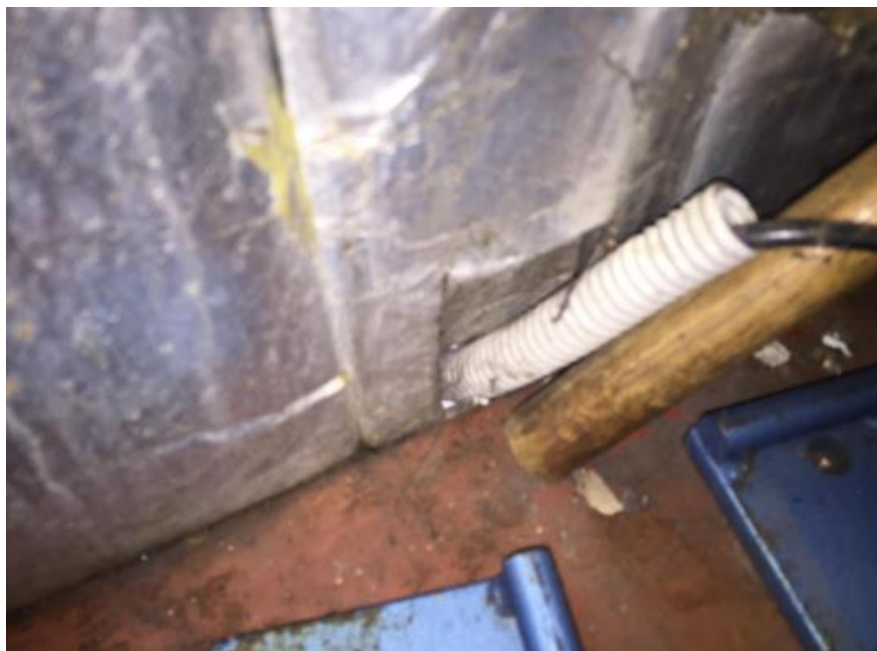
Site Photograph 12 – penetration through fly tower cladding

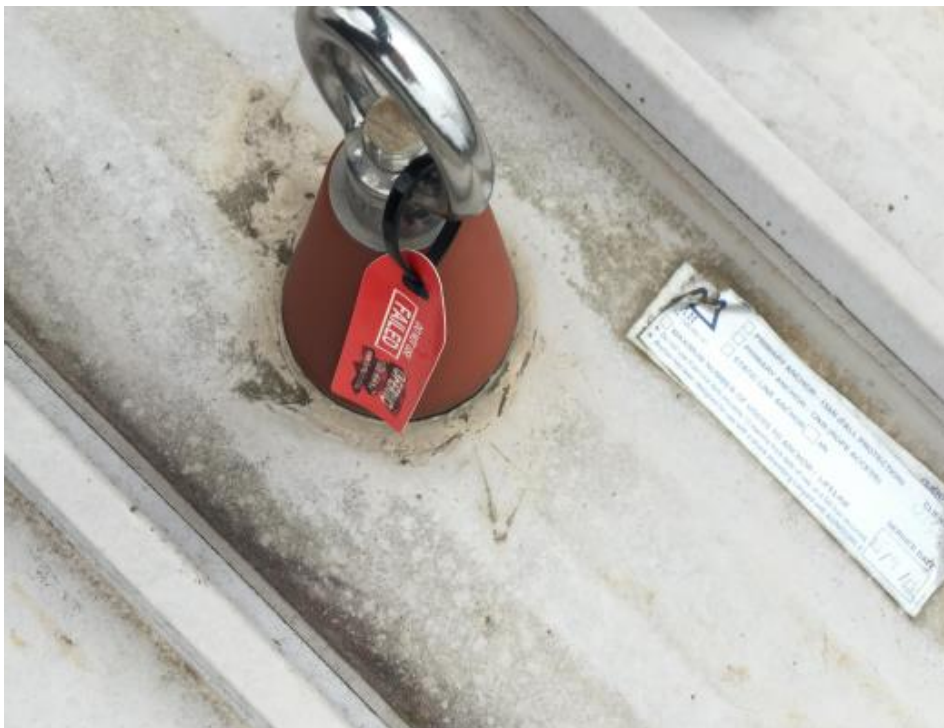
Site Photograph 14 – majority of anchor points had been recently tested and tagged “failed”

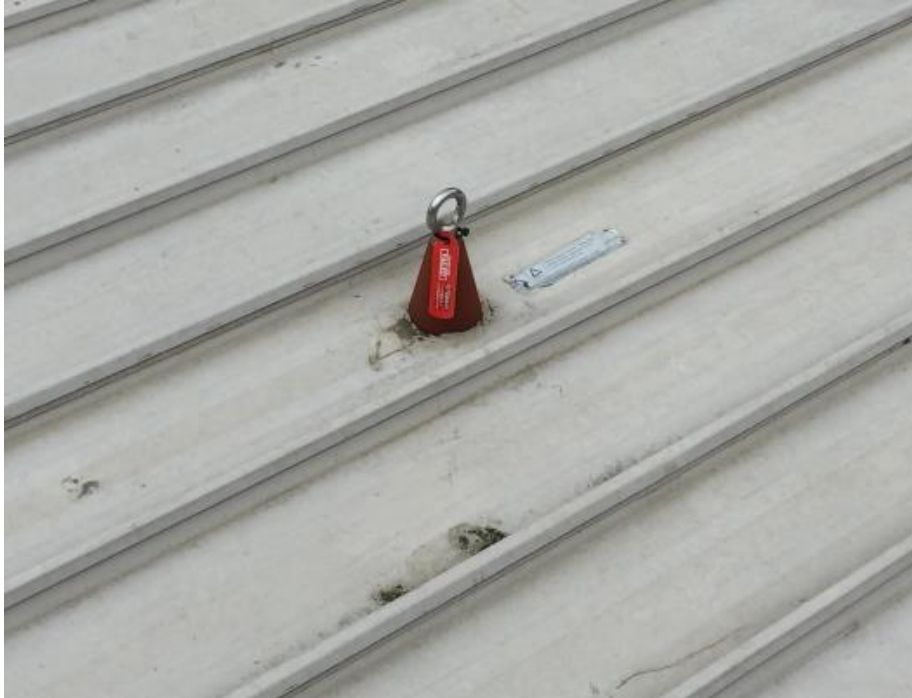
Site Photograph 15 – majority of anchor points had been recently tested and tagged “failed”

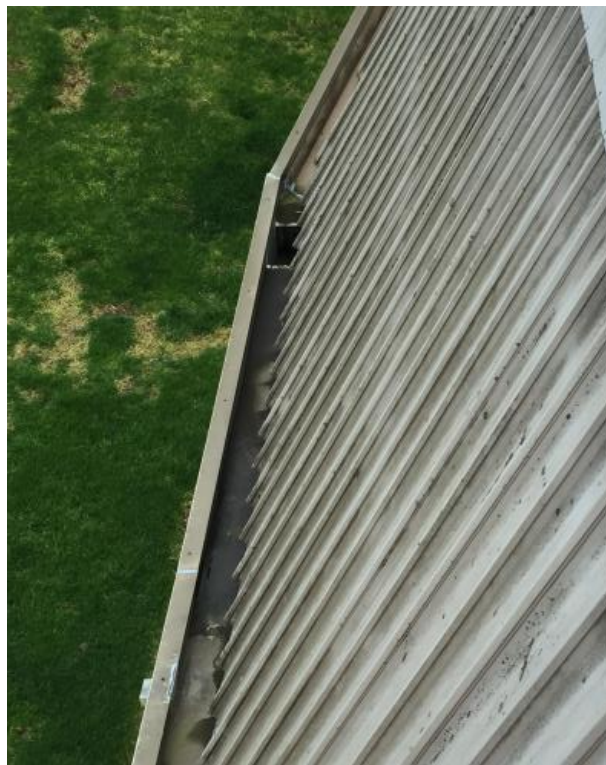
Site Photograph 16 – gutters generally appeared well maintained on inspection

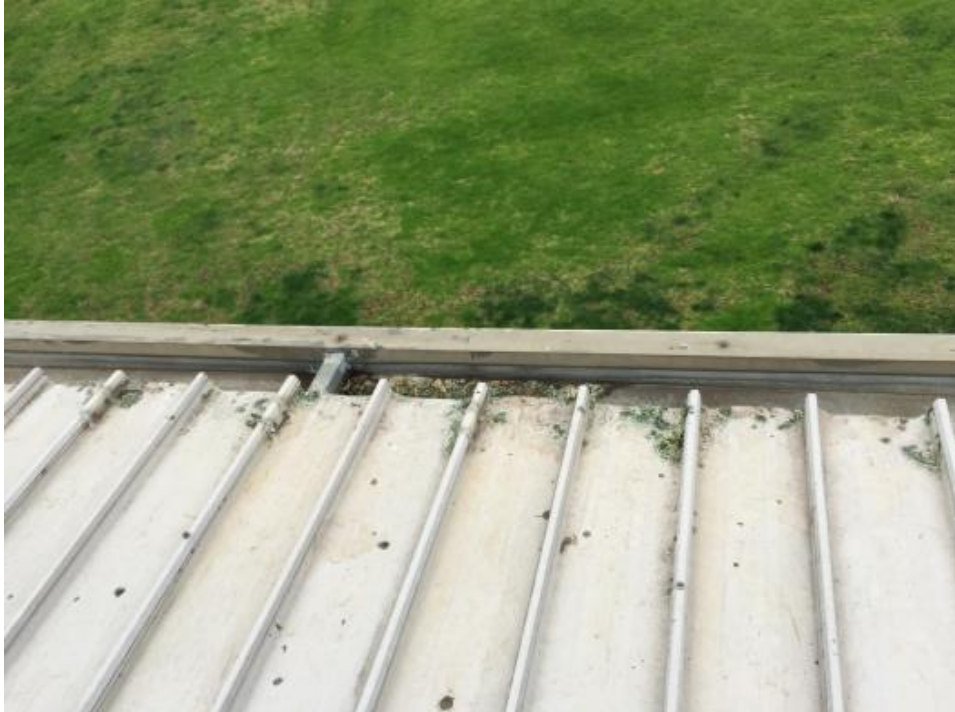
Site Photograph 17 – gutters generally appeared well maintained on inspection, appeared moisture has ponded on areas of roof sheet (mould build up)

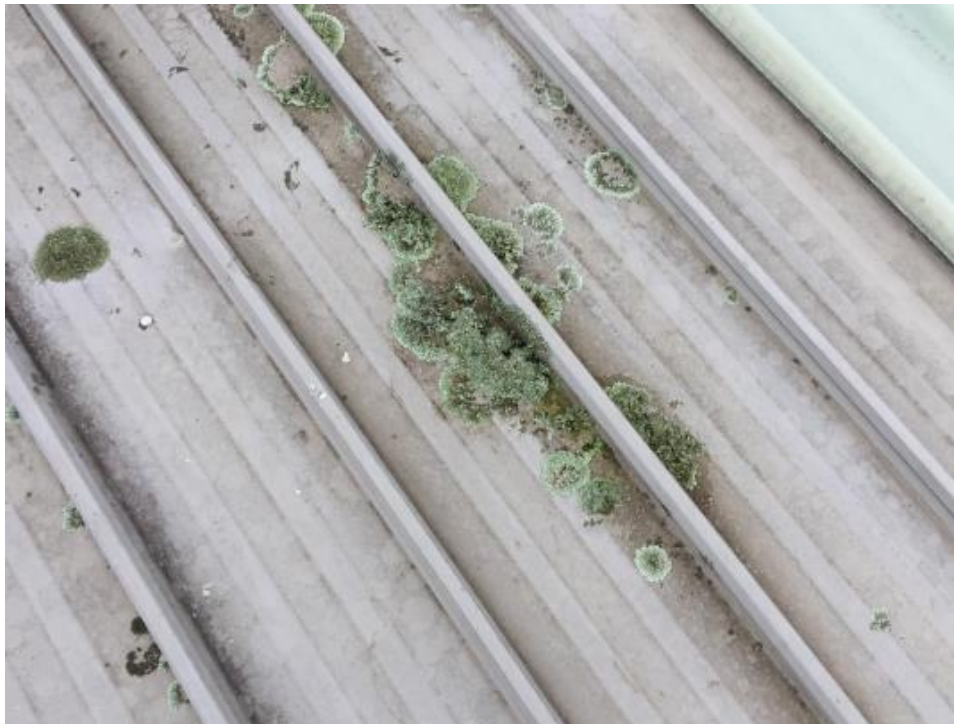
Site Photograph 18 – mould build up sighted, possibly from water ponding on roof deck

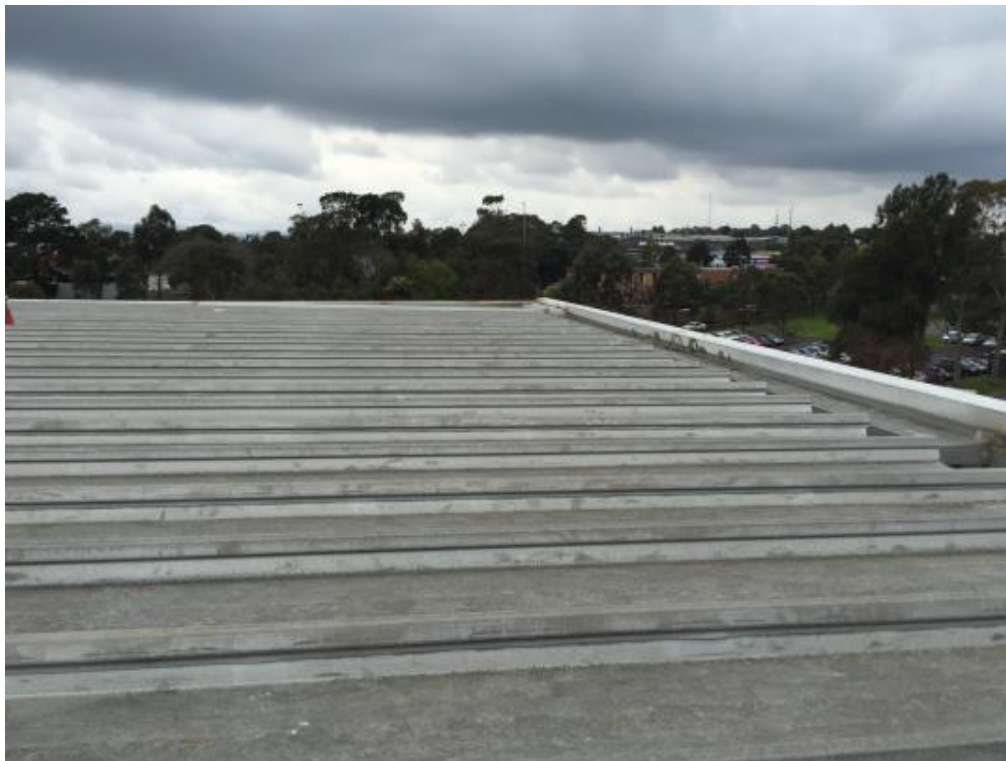
Site Photograph 22 – very slight fall in fly tower roof deck
